Manhole Inspection Summary

Manhole # S35C__062MH

Insp Date: **8/21/08 2:59 PM**

Location Address: **222 davis st**

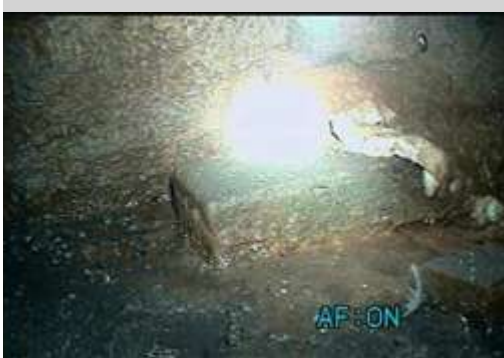
Misc

bench debris

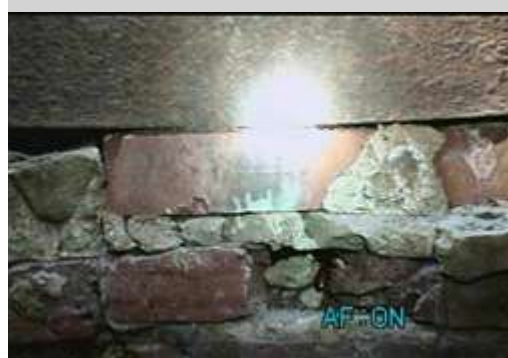
Defect 2

Condition: ☐ Sound ☒ **Cracked** ☐ Root Intrusion ☒ **Loose Brick** ☒ **Deteriorated**

chimney loose bricks, deteriorated,
cracked, frame adj

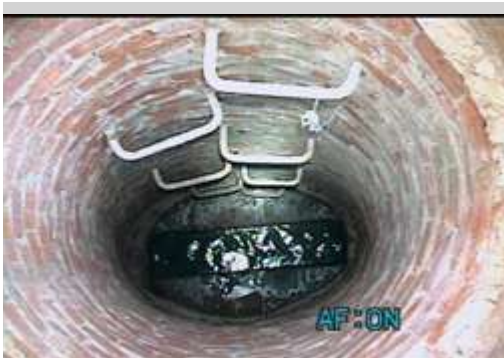
Defect 1

Steps Count: **7** Missing: **0** ☒ **Corroded**

steps

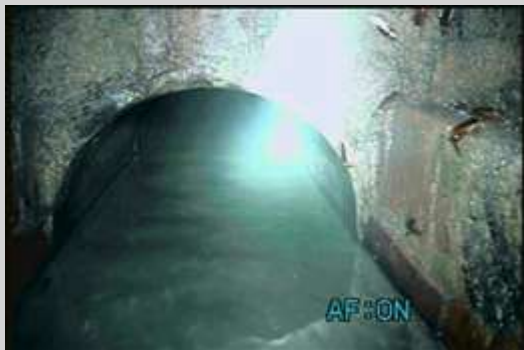
12 O'Clock Outflow

15 in. Circular Gravity Sewer
Pipe Out @ 12 O'Clock

Pipe Material: **Clay** ☐ Pipe Lined

Invert Depth: **12.60** (ft.) Flow Characteristics: **Fast**

Infiltration: **None** Pipe Seal Cond: **Unknown**

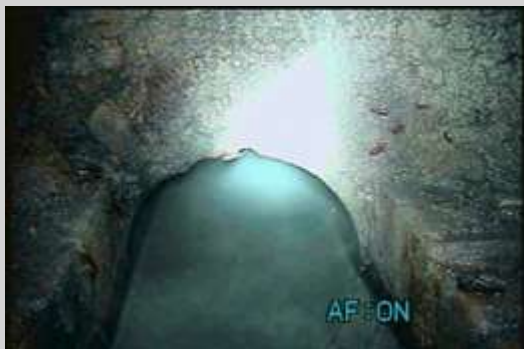
6 O'Clock Inflow

15 in. Circular Gravity Sewer
Pipe In @ 6 O'Clock

Pipe Material: **Clay** ☐ Pipe Lined

Invert Depth: **12.50** (ft.) Flow Characteristics: **Fast**

Infiltration: **None** Pipe Seal Cond: **Unknown**
